Manhole Inspection Summary

Manhole # S35II1019MH

Location Address: **4014 GREENWAY**

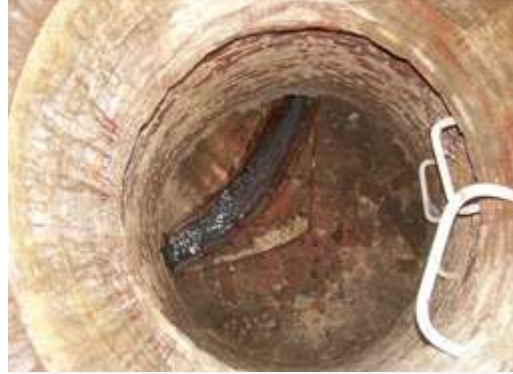
Top View

Evidence of surcharge- Bench debris.

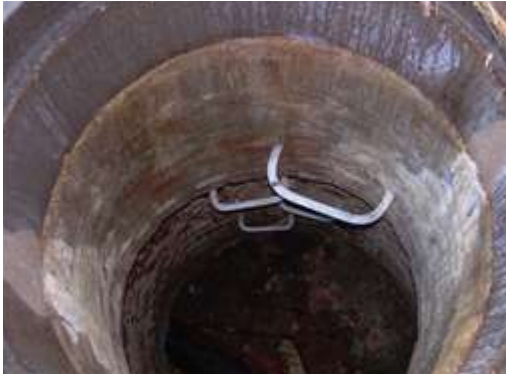
Defect

Frame leaks. Adjustment deterioration and infiltration. Corbel and Barrel infiltration.

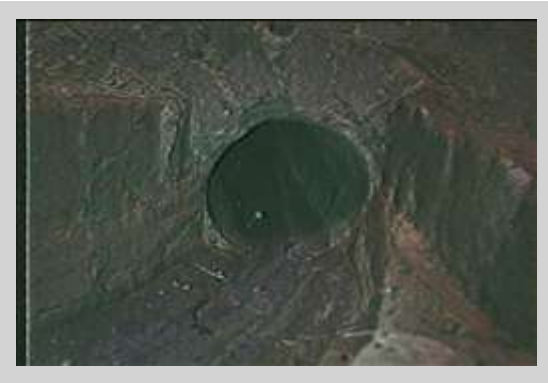
8 in. Circular Gravity Sewer Pipe Out @ 12 O'Clock

Channel deterioration.

Infiltration: **Evidence** Pipe Seal Cond: **Cracked**

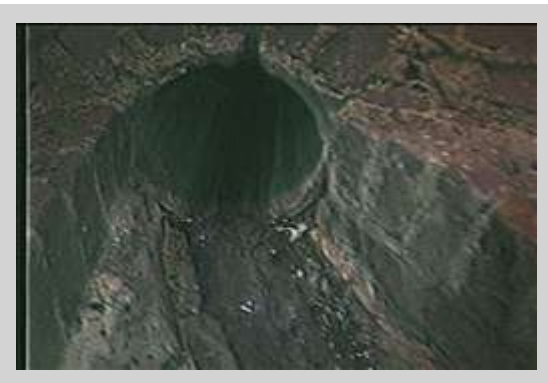
8 in. Circular Gravity Sewer Pipe In @ 8 O'Clock

Infiltration: **None** Pipe Seal Cond: **Broken**
